The Uniform Building Inspection Report™

817 Via Gaviota, Aptos, Ca. 95003

Inspection Date:
4/16/08, 1:00:00 PM

Report Number:
20080416p

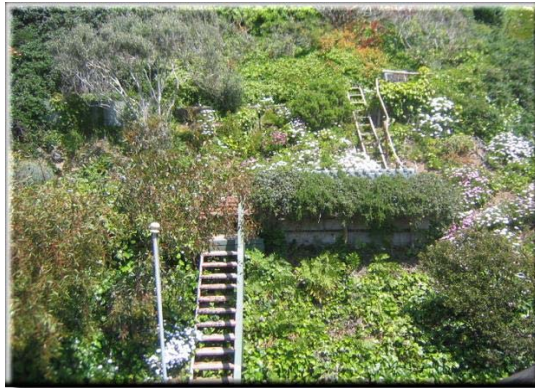
Photo: 0100 (1)

[N] 0100: Review by Geologist or Soils Engineer advised. Due to the nature of the grounds this review is recommended. Noted at the rear of the structure. Discretion advised. The significance of the finding is uncertain. Further study by a qualified licensed contractor is advised.

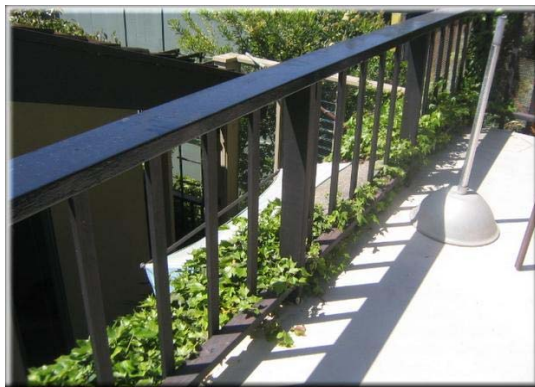
Photo: 0290.11 (1)

[U] 0290.11: Patio/deck guardrail improper. The balusters exceed 4 inches on center. This can be considered hazardous if small children or animals are using the deck. Noted at the rear of the structure. Modification or addition is generally considered an upgrade which should improve safety or efficiency. The opinion of a qualified licensed contractor is recommended.

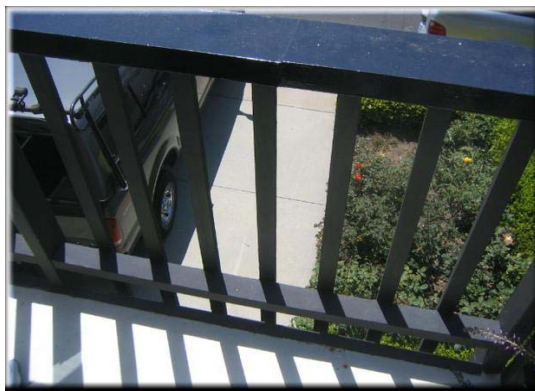
Photo: 0290.11 (2)

[U] 0290.11: Patio/deck guardrail improper. The balusters exceed 4 inches on center. This can be considered hazardous if small children or animals are using the deck. Noted on the front balcony. Modification or addition is generally considered an upgrade which should improve safety or efficiency. The opinion of a qualified licensed contractor is recommended.

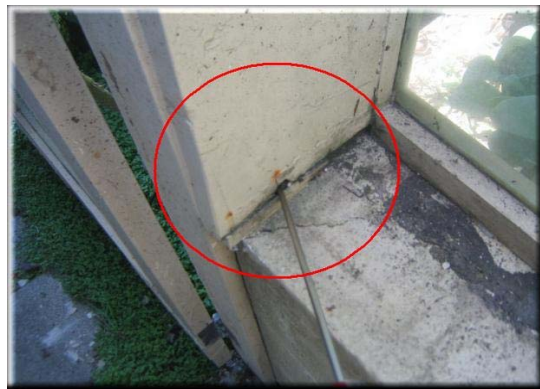
Photo: 0960 (1)

[E] 0960: Finding not covered in the narratives. The wood framing for the gate on the left side of the house is damaged by wood rot. Repair, alteration or replacement

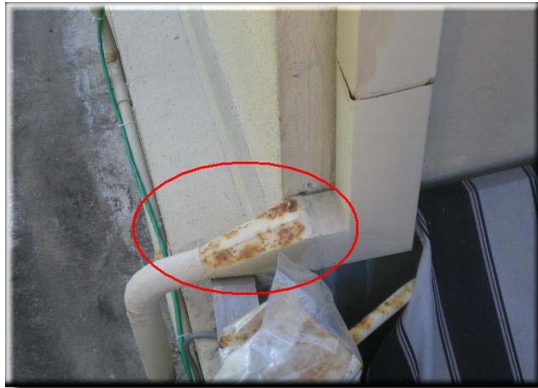
Photo: 1280.11 (1)

[E] 1280.11: Downspout damaged.

Repair, alteration or replacement usually improves the efficiency of the component or system.

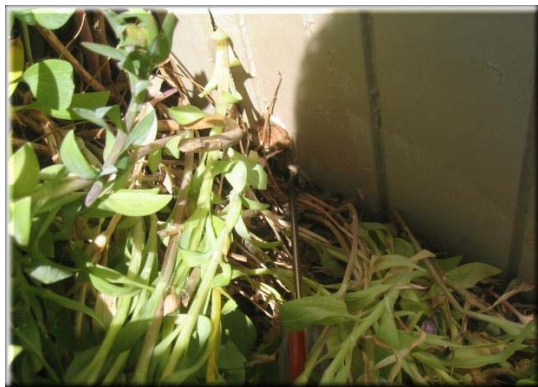
Photo: 1310.04 (1)

[E] 1310.04: Siding damaged.

Repair, alteration or replacement usually improves the efficiency of the component or system.

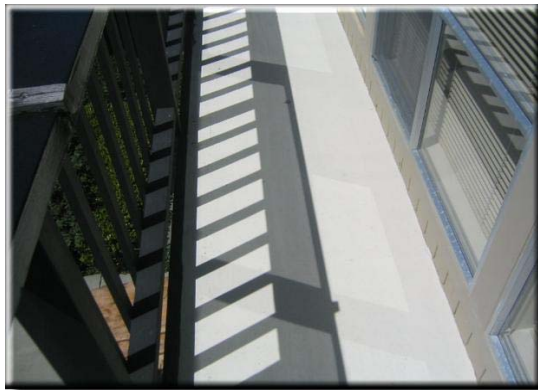
Photo: 1940 (1)

[N] 1940: Unexpected repairs and maintenance.

The front upper balcony deck has an Elastomeric coating installed. Be aware that the inspector cannot ascertain with any degree of accuracy whether this type of deck coating leaks or was properly installed. Discretion advised. The significance of the finding is uncertain. Further study by a qualified licensed contractor is advised.

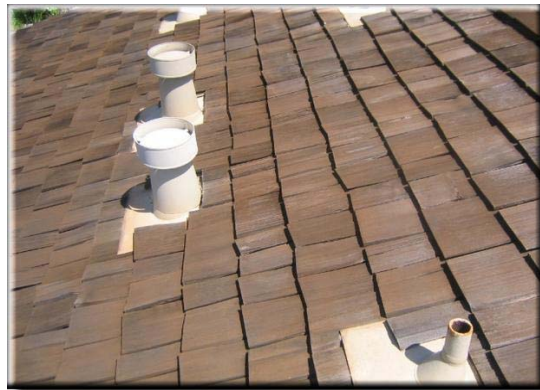
Photo: 1950 (3)

[M] 1950: Finding not covered in narratives.
The wood shake roof cover appeared to be in generally good condition at this date. Monitor the situation on a regular basis. Corrections by a qualified licensed contractor, if and when necessary, are recommended.
See photo(s): 1950

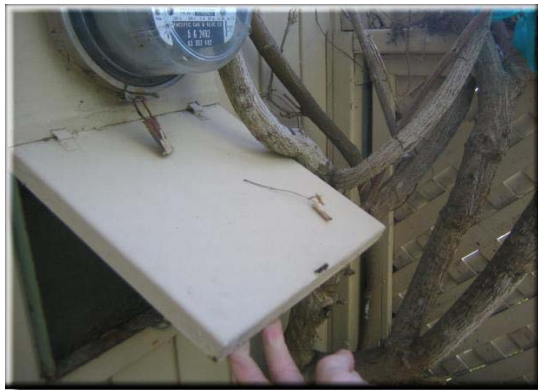
Photo: 5110.03 (1)

[R] 5110.03: Main panel adjacent wall covering faulty. (Affects front cover operation).

Vegetation is blocking the operation of the main panel cover. It is recommended that the finding be reviewed, and corrected as needed, by a qualified licensed contractor before purchasing the property. See photo(s): 5110.03

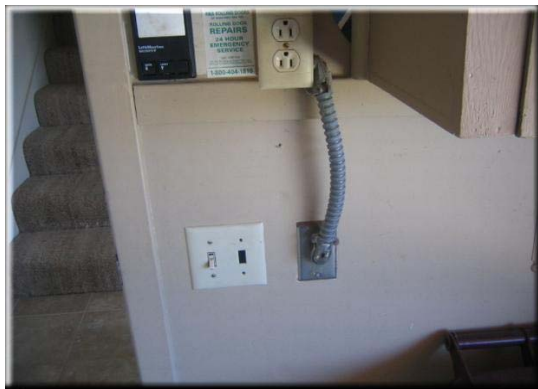
Photo: 5470 (1)

[N] 5470: Electrical additions/modifications noted.

The visual inspection is not a code compliance inspection and connections made to an electrical system are covered by stringent code requirements. Check for permits and municipal inspection records. It is recommended that you contact an Electrical Contractor for additional information and an additional opinion. Noted at various locations. Discretion advised. The significance of the finding is uncertain. Further study by a qualified licensed contractor is advised.

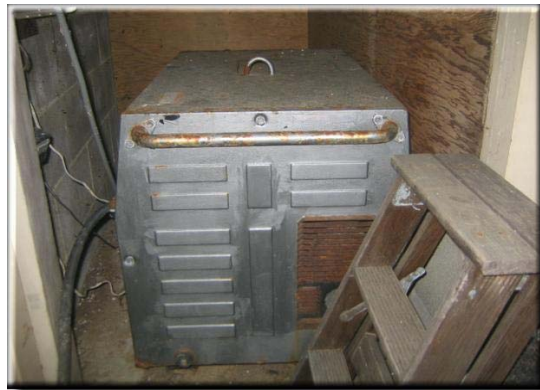
Photo: 5910 (1)

A back up generator is in place. All visible electrical components for the generator and related equipment appeared to be properly installed and in good condition. An interior investigation of the generator isolation panel was beyond the scope of this inspection and was not thoroughly evaluated. Refer to the manufacturers recommendation for inspection and maintenance of the panel. The permit for this equipment should be checked for code compliance. Discretion advised. The significance of the finding is uncertain. Further study by a qualified licensed contractor is advised.

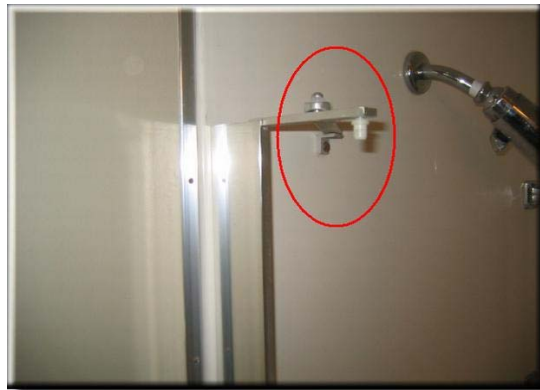
Photo: 6060.10 (1)

[E] 6060.10: Shower door removed.
Repair, alteration or replacement usually improves the efficiency of the component or system.
See photo(s): 6060.10

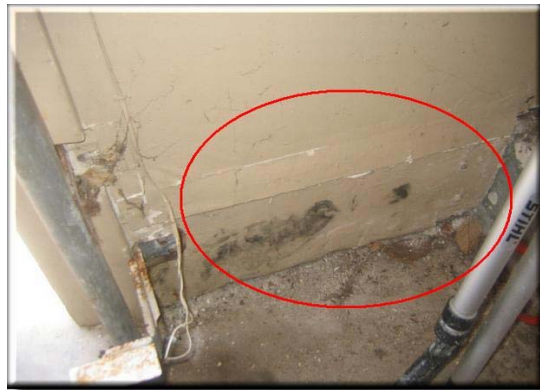
Photo: 7010 (1)

[N] 7010: Water intrusion evidence or water damage noted. Stained or water damaged ceilings or walls can be positive indicators of ongoing roof, plumbing, or other leaks. The inspector will not always be able to ascertain whether the water intrusion is ongoing or has been repaired. Noted in the garage. Discretion advised. The significance of the finding is uncertain. Further study by a qualified licensed

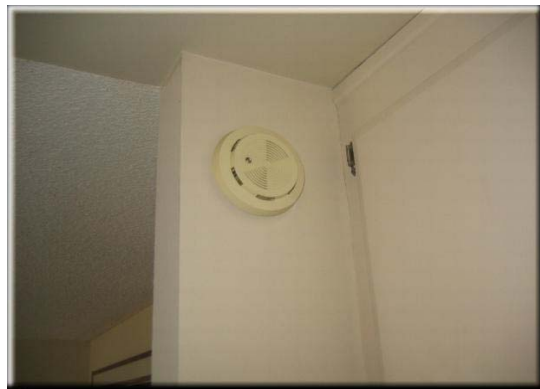
Photo: 7930 (1)

[U] 7930: Unexpected repairs and maintenance.
Alarm operation is generally not tested by the inspector.
Operation today does not guarantee operation tomorrow
and it is extremely important that the smoke alarm and/or
CO alarm properly operate at ALL times. You are advised to
test the alarm immediately upon taking possession of the
property and on a regular basis thereafter to ensure it
operation. Modification or addition is generally considered
an upgrade which should improve safety or efficiency. The
opinion of a qualified licensed contractor is recommended.
See photo(s): 7930

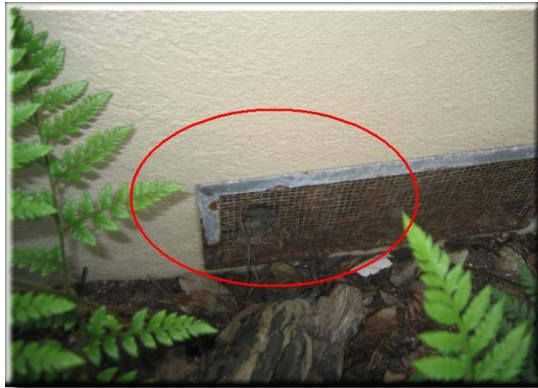
Photo: 9440.12 (1)

[E] 9440.12: Sub-area ventilation screens faulty or otherwise amiss.

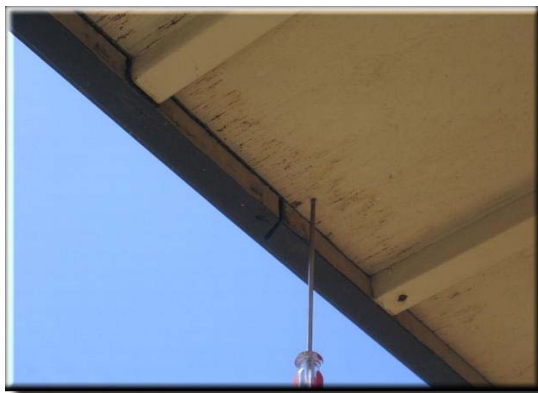
Photo: 9840 (1)

[R] 9840: Wood deterioration noted on building member.

Wood rot and water stains were found on the bottom of the enclosed upper balcony. This may indicate moisture intrusion through the waterproof membrane(if any) or inadequate drainage. It is recommended that the finding be reviewed, and corrected as needed, by a qualified licensed contractor before purchasing the property.

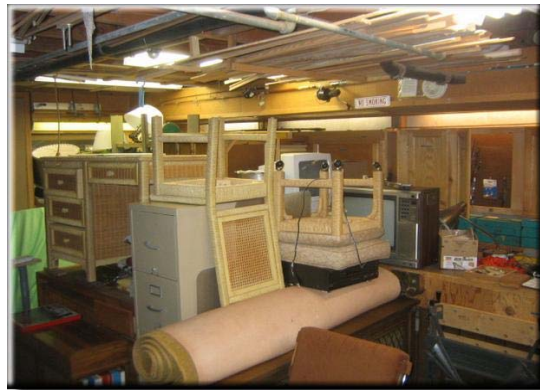
Photo: 9870 (1)

[Note] 9870: Access impaired.

Portions or all of the building are constructed on a concrete slab floor with various types of floor covers installed over the concrete. Cracks can be concealed under the floor covers. The absence or presence of seismic fasteners could not be determined. Nearly all homes with slab foundations that were originally built to code will have anchor bolts or straps.
