The Uniform Building Inspection Report™

817 Via Gaviota, Aptos, Ca. 95003

Inspection Date:
4/16/08, 1:00:00 PM

Report Number:
20080416p

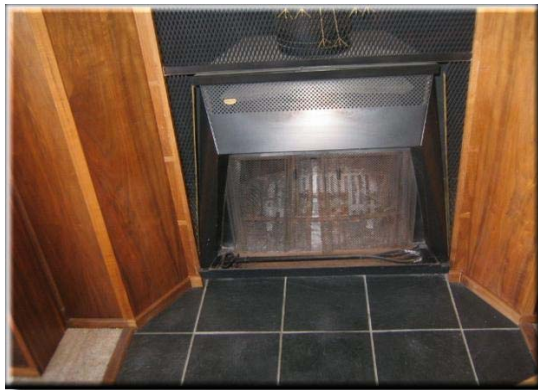
Photo: 2830 (1)

It is suggested that all fireplace and chimneys be reviewed, cleaned or corrected if needed before use.

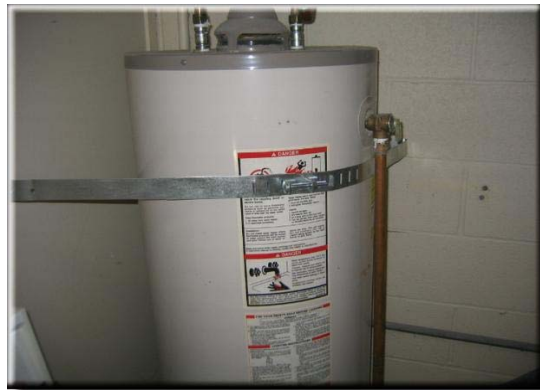
Photo: 4980 (2)

[Note] 4980: Finding not covered in narratives. The seismic strapping system provided on this water heater has been adequately installed and meets current strapping requirements. The metal exhaust vent pipe appears to be in

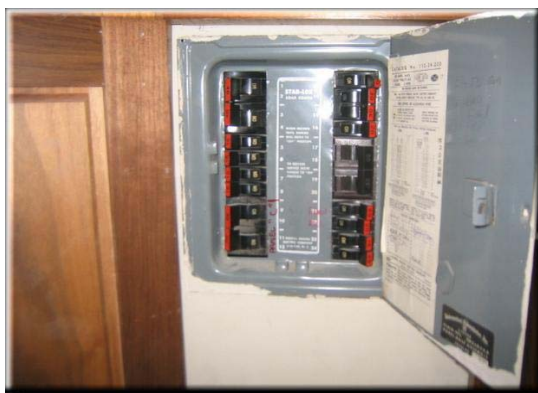
Photo: 5890 (1)

[N] 5890: Unexpected repairs and maintenance.

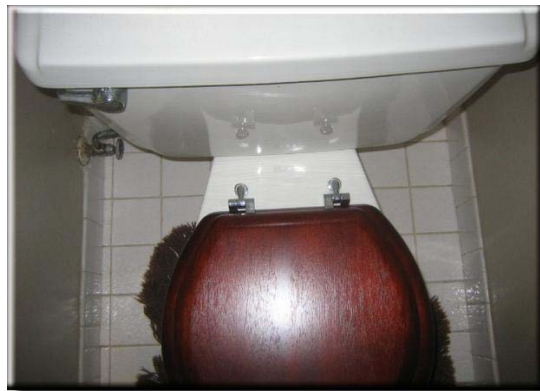
Photo: 6880 (1)

[Note] 6880: Finding not covered in narratives.
The bathroom counter tops and cabinets appeared to be in generally good condition at this inspection date. The sinks and plumbing unless otherwise mentioned appeared to function as intended and were in generally good condition.
Noted in all baths.
See photo(s): 6880

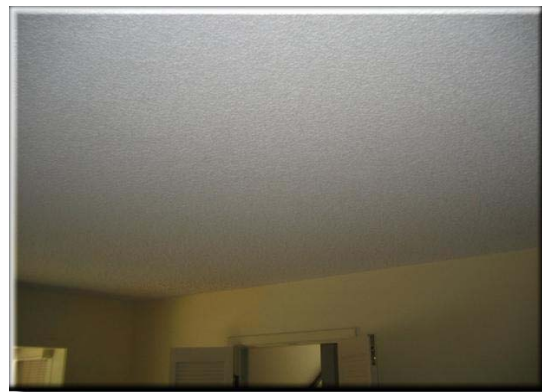
Photo: 7950 (2)

[N] 7950: Finding not covered in narratives.
Acoustic ceilings are present in this building. Be aware that some acoustic ceiling materials contain asbestos fibers, depending on the age of the material. Any heavy alteration of this type of ceiling is not recommended until laboratory tests confirm the lack of asbestos content. The Visual Inspection Service does not include such testing. Discretion advised. The significance of the finding is uncertain. Further study by a qualified licensed contractor is advised. See photo(s): 7950

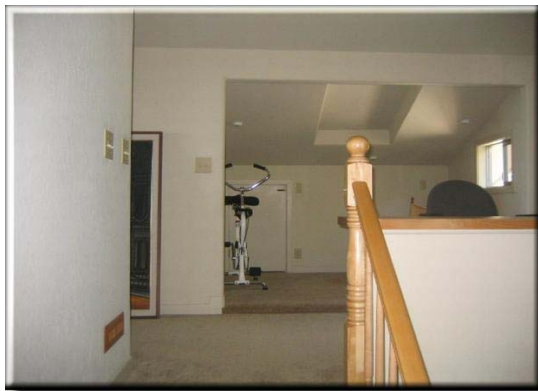
Photo: 9810 (1)

This item is checked if the inspector notes any newer electrical work, plumbing work, HVAC work, structural changes, kitchen, bathroom remodels etc. The work may be perfect in appearance and the work may be old or new modifications. The inspector will not ascertain whether the remodel or repairs complies with applicable building codes or whether permits were obtained.
