WOOD DESTROYING PESTS AND ORGANISMS INSPECTION REPORT

Building No. 817	Street VIA GAVIOTA	City APTOS	Zip 95003	Date of Inspection 4/16/2008	Number of Pages 5
---------------------	-----------------------	---------------	--------------	---------------------------------	----------------------

GENERAL DESCRIPTION: 2 STORY/SINGLE FAMILY RESIDENCE/CONCRETE SLAB FLOOR/RAISED FOUNDATION/STUCCO AND WOOD SIDING/WOOD SHAKE ROOF COVER/FURNISHED AND OCCUPIED/WEATHER DRY	Inspection Tag Posted: ATTIC
	Other Tags Posted: NONE FOUND

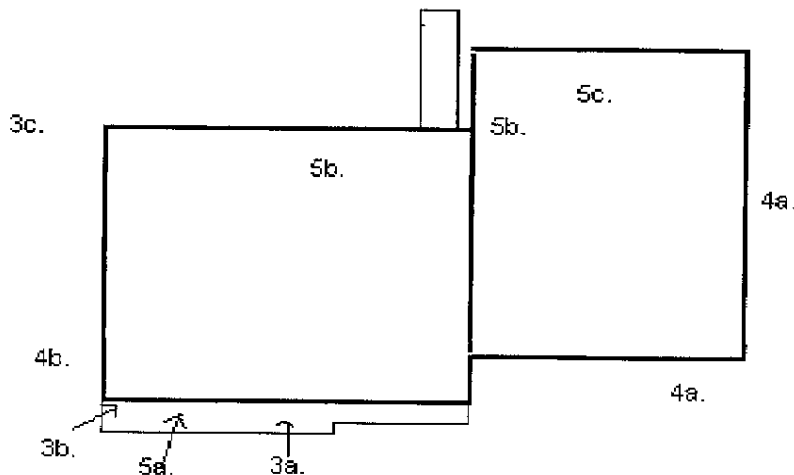
Diagram Not To Scale

An inspection has been made of the structure(s) shown on the diagram in accordance with the Structural Pest Control Act. Detached porches, detached steps, detached decks and any other structures not on the diagram were not inspected.
